#### **VIBRATION TEST REPORT**

: ENVA10070504

Product Model Number: S9

# 6. PHOTOS & FIGURES OF TEST

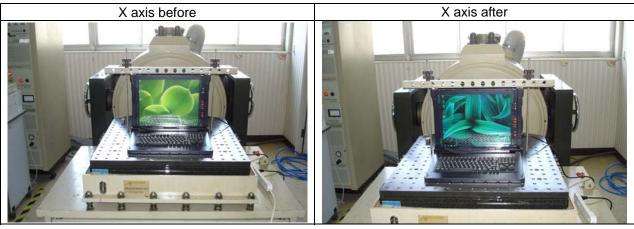
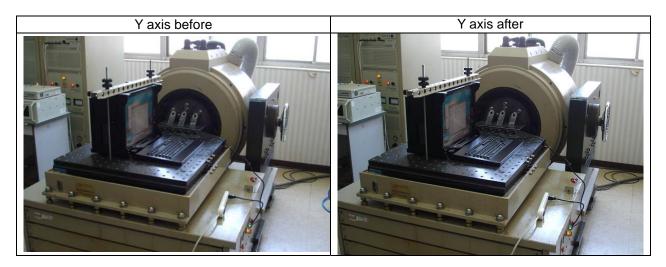
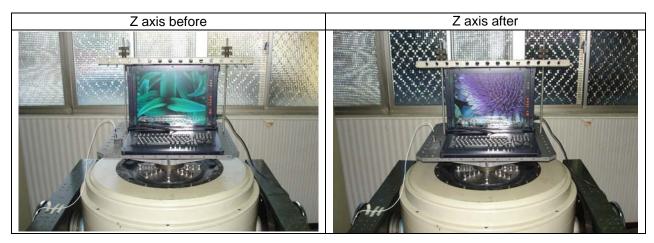
#### PHOTOS

ITEM		FREQ.; STRENGTH; SWEEP RATE	DURATION TIME	DIRECTION	OPERATION	REMARK OR SPECIMEN	TEST RESULT
1	swept sine	20Hz- 60Hz, 0.075mm (peak to peak)	30min per axis	X, Y, Z	Operating	Unpacking	AA
